## SHADY DELL RIVERVIEW SOUTH CONDOMINIUM

3150 N. Harbor City Blvd, Melbourne, FL

### MILESTONE INSPECTION

February 21, 2024

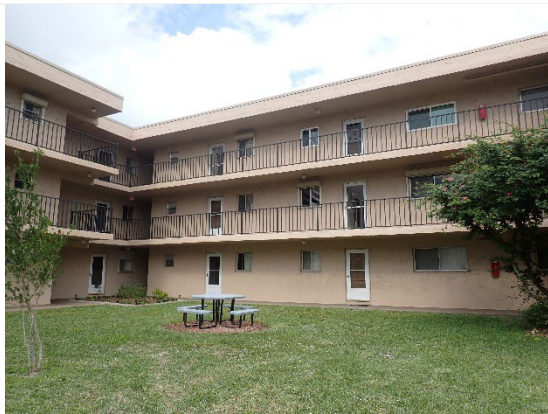
*Photograph 3: A Building*

**A Building (3 stories, 39 units)** – No substantial structural deterioration and ONE unsafe condition were found at the A Building. The guard/screen enclosure in Unit A333 is considered unsafe. The board escort and unit occupant were notified of the unsafe condition. 21 balconies were evaluated visually and acoustically along with all the walkways and the building exterior. A few deck, edge and overhead spalls were noted. The unsafe condition should be remedied immediately, and the other items should be repaired during the next repair cycle. The building is generally in good condition. The East stairwell appears to be separating from the building and should be monitored.

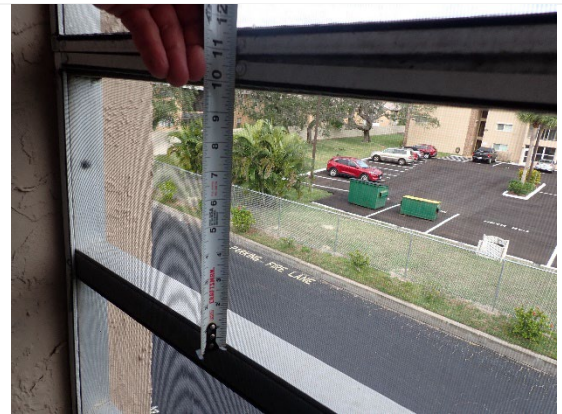
*Photograph 4: ~10" Spacing*

**GUARDRAILS:** The guardrails on both the balcony side of the buildings as well as the walkways dimensionally do NOT meet current building code as the spacing is larger than 4". The spacing on the balcony screen enclosures is ~10" which is very concerning. Structurally "Handrails and guards shall be designed to resist a concentrated load of 200 pounds in accordance with Section 4.5.1 of ASCE 7." And "Handrails and guards shall be designed to resist a linear load of 50 pounds per linear foot in accordance with Section 4.5.1 of ASCE 7."<sup>1</sup> The guardrails on the balconies appear to mostly be in poor condition and it is unlikely that they could withstand the required loading and replacement is recommended. The guardrails on walkways appear to be mostly in fair condition and replacement should also be considered. It should be noted that not all the balcony guards were inspected and there could be more instances of unsafe conditions.

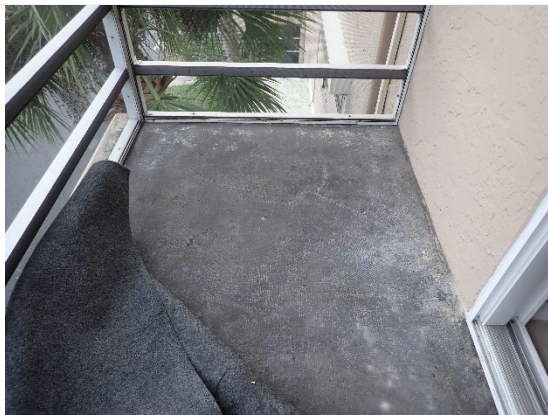
*Photograph 5: Carpet on Balcony*

**CONCRETE PROTECTION:** The deck coatings on all the balconies are of varying type and age. It is typically recommended that all units have the same protective coating. In this case, a couple balconies are fully enclosed and therefore almost considered "interior space" so are excluded. Tile, carpet, rugs and any other covering is not recommended on any exterior elevated concrete surface. All will hold moisture, and subsequently chlorides, against the deck accelerating the corrosion process. A waterproof coating is always recommended and is the best line of defense against moisture and chloride intrusion into the structure. New deck coatings are recommended on both the balconies and walkways. The walkways likely have a 2" cementitious overlay which is cracked and delaminated throughout. It is recommended that this overlay be removed and replaced.

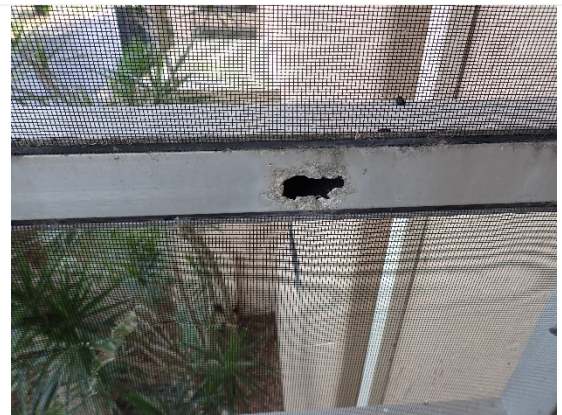
*Photograph 6: Pitted Aluminum Guard*

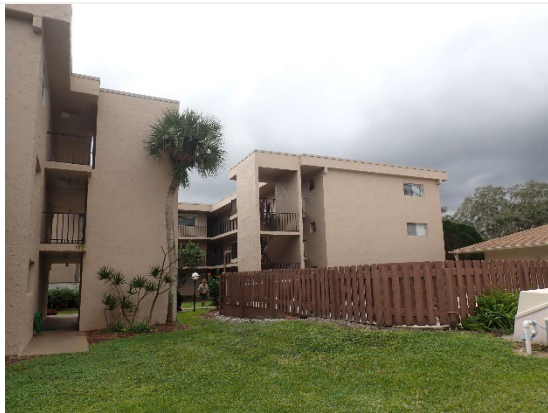
*Photograph 7: B Building*

**B Building (3 stories, 30 units)** – No substantial structural deterioration and FIVE unsafe conditions were found at the B Building. The guard/screen enclosures in Unit B344, B345, B246, B346 are considered unsafe. The board escort and unit occupant were notified of the unsafe condition. There was also an unsafe rail on the 3<sup>rd</sup> floor walkway on the NW corner. 12 balconies were evaluated visually and acoustically along with all the walkways and the building exterior. A few deck, edge and overhead spalls were noted. The unsafe condition should be remedied immediately, and the other items should be repaired during the next repair cycle. The building is generally in good condition.

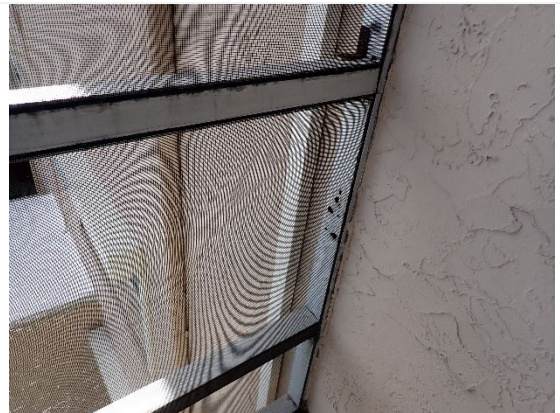
*Photograph 8: B345 UNSAFE ~20" opening*

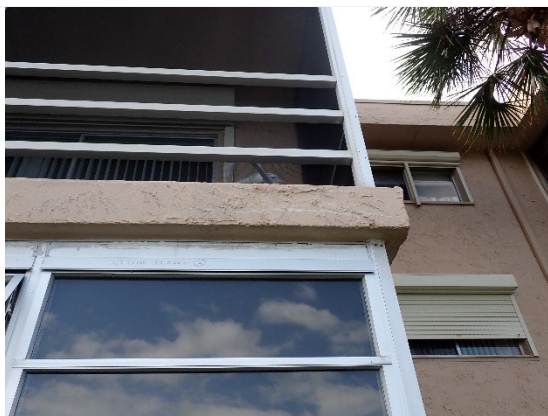
*Photograph 9: Edge crack*

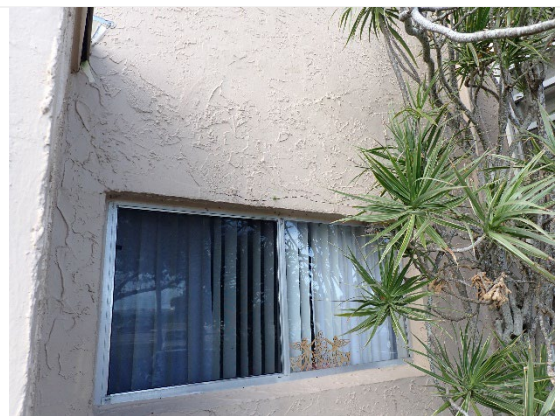
*Photograph 10: Header Damage*
